THE MOAT HOUSE

Archaeological Observation at The Bishop's Palace, Alvechurch, Worcestershire

Report 1059

December 2010

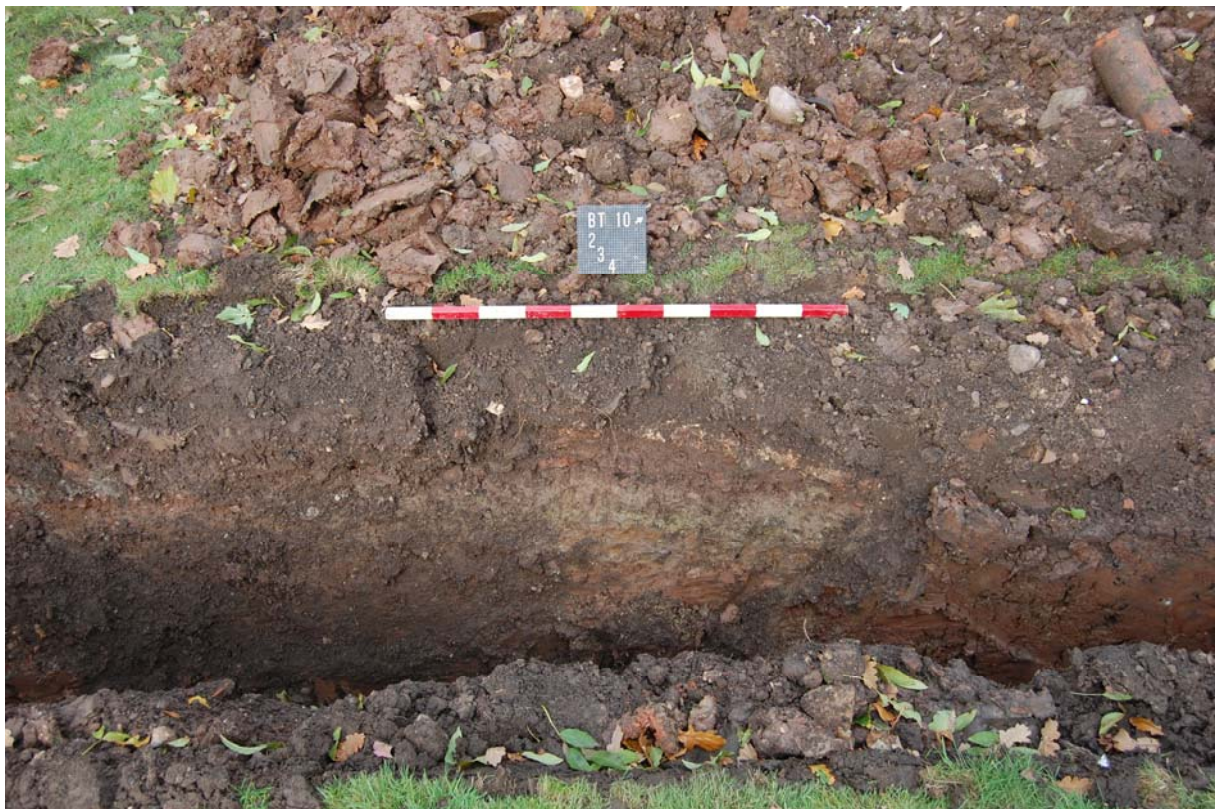
Fig 5 New manhole area looking north-east, layers 1-4

4.1 The groundworks consisted of the excavation of a manhole and trench for the replacement drain using a tracked mini-excavator with a toothless bucket (Figs 2-7). The trench measured 0.50m wide by 1.10m-1.25m deep, being deepest in the area of the new manhole (Fig 5) where it also widened out to c0.85m for a c2.5m stretch. The majority of the trench was cut entirely within the fill of a pre-existing pipe trench and thus did not expose any earlier deposits. This was apart from a widened area for the new manhole at the south-west end of the trench (Fig 5), and the dog-leg stretch running west from the north-east end of the pre-existing pipe towards the house (Figs 6 & 7).

4.2 In the area of the manhole (Fig 5) the geological natural strong brown clay (4) was recorded at c0.54m below the existing ground surface. This was overlain by a c0.10m thick layer of greenish grey sandy clay (3) that may itself have been a variation of the geological natural. Layer 3 was overlain by a c0.14m thick layer of greyish brown clay loam (2) that contained frequent small fragments of ceramic roof tile (not retained) and mortar flecks. This probably represents demolition material derived from a former building within the contemporary garden soil. Layer 2 was cut by the pre-existing sewer pipe trench, aligned roughly south-west to north-east. It was backfilled with a ceramic pipe (7) that lay at c1m below the existing ground surface. The pipe was overlain by a mixed deposit of greyish brown clay loam, strong brown clay and ash (6) from which a single sherd of 19th century willow pattern pottery and an iron object were noted. Pipe trench fill 6 was overlain by the c0.30m thick layer of dark greyish brown clay loam of the existing garden soil (1).

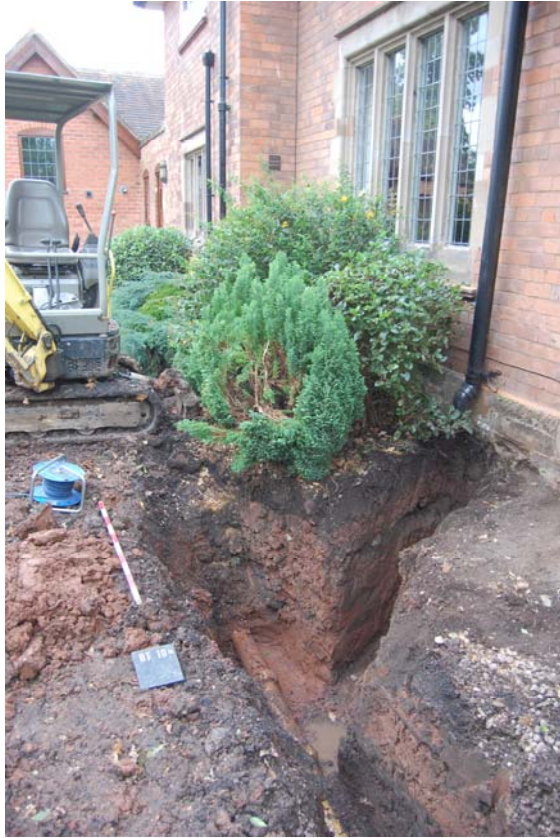
Fig 6 Dog-leg trench looking north-east

4.3 In the dog-leg trench (Figs 6 & 7) geological natural strong brown clay (4) was recorded at c1m below the existing ground surface. A further pipe trench (8) ran aligned roughly south-west to north-east, parallel to pipe 7 and slightly north-west of it. Pipe trench 8 had a ceramic pipe (10) in its base overlain by a backfill (9) identical to trench fill 6. Pipe trenches 5 and 8 were thus probably contemporary. Trench fill 9 was overlain by the c0.24m thick dark greyish brown clay loam (11) of the existing flower bed.
